Information Booklet

Volume 1

Volume 2

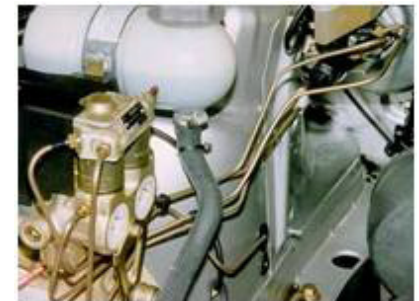
Figure 1. Copper-nickel brake lines running from master cylinder in 1990 Volvo.

Figure-1 shows the installation at the master cylinder in a 1990 model Volvo. Audi began using this material in 1990. The other European cars using this material are Porsche and Aston Martin.²

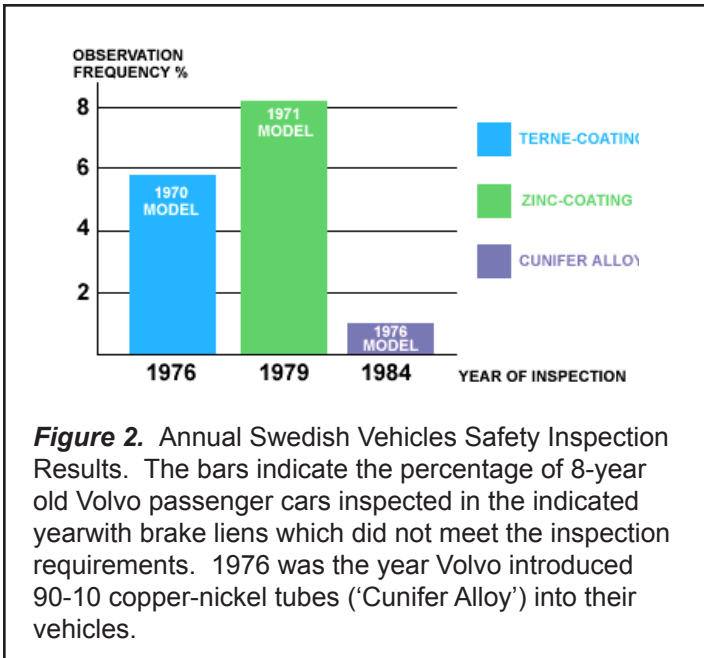
The bar graph shown in **Figure-2** depicts the percentage of vehicles failing safety inspections because of defects in the brake systems of eight-year-old Volvo passenger cars.

The 1970 model cars had terne-coated steel tubes. Tubes in the 1971 models were zinc coated. Defects other than rusted tubes are included in these values, but their effect on the data is minimal. The reduction in defects related to the introduction of 90-10 copper-nickel tube in 1976 is dramatic.

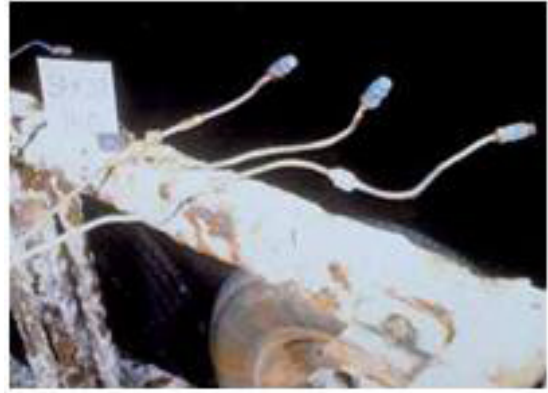
Figure 3. Brake line samples attached to test trailer.

The trailer is exposed to salt, dust and stone pecking as well as temperature and humidity variations. The total humidity soak time is approximately 2,600 +/-25 hours. The total drying chamber soak time is 375 +/-25 hours. The test trailer accumulates approximately 13,800 km (8,600 miles) during the full test cycle.

Figure 3 shows test samples attached to a typical test trailer.

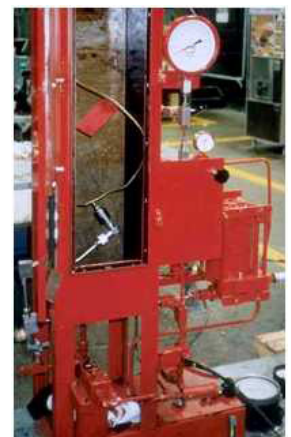
Figure 4. Equipment used to test hydrostatic pressure in brake tube.

Beginning with the 40th cycle, and at 10-cycle intervals thereafter, each tube is subjected to an internal pressure test of 20,684 kPa (3000 psi). Candidate materials must complete 60 cycles to satisfy the minimum requirement. **Figure-4** shows the test equipment on which the hydrostatic pressure tests were made.

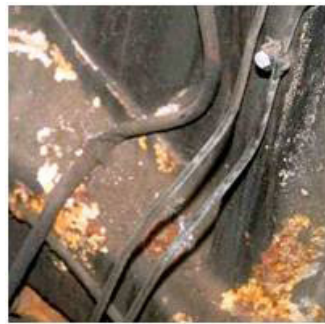
Figure 5. Engine compartment of 1976 Volvo showing uncorroded copper-nickel brake lines.

Figure-5 shows the engine compartment of a 1976 model Volvo four-door sedan. The vehicle was located in the storage yard of a used automobile parts dealer. The engine had already been removed and the actual mileage is not known. However, using the corrosion in the engine compartment as a criterion, it can be concluded that the uncorroded copper-nickel brake tubes which can be seen exiting from the master cylinder had, indeed, survived a hostile, corrosive environment.

The brake tubes were removed from this vehicle and hydrostatic burst tested with the following results:

Tube No. 1	111,694.95 kPa	(16,200 psi)
Tube No. 2	106,868.62 KPa	(15,500 psi)
